Surveying microplastic release from aquaculture nets and ropes using different technologies for emission reduction (SMARTER)

FHF Dialogmøte - Beste praksis for not-strategi, Wednesday 3rd Sept, Gardermoen

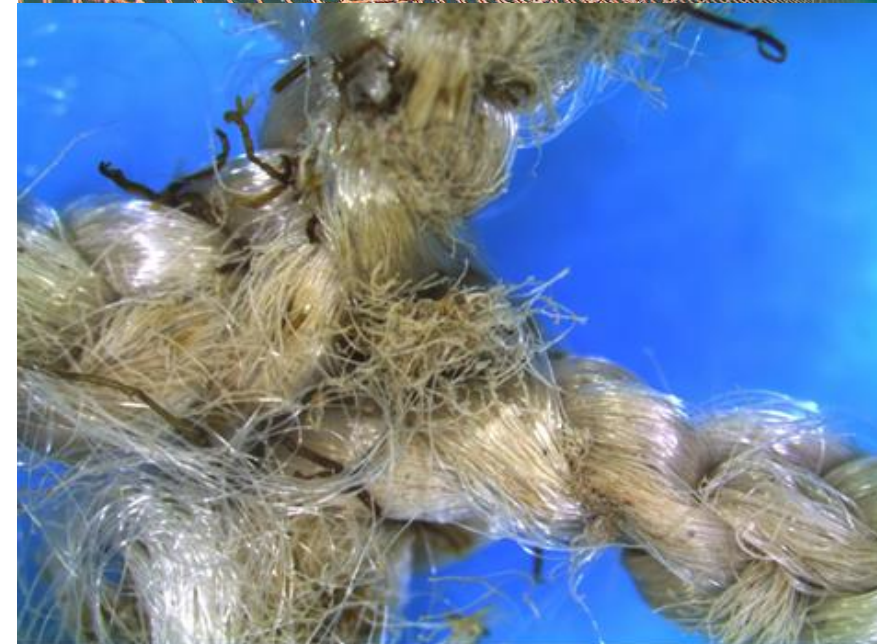
Wear on aquaculture nets
from high pressure cleaning.

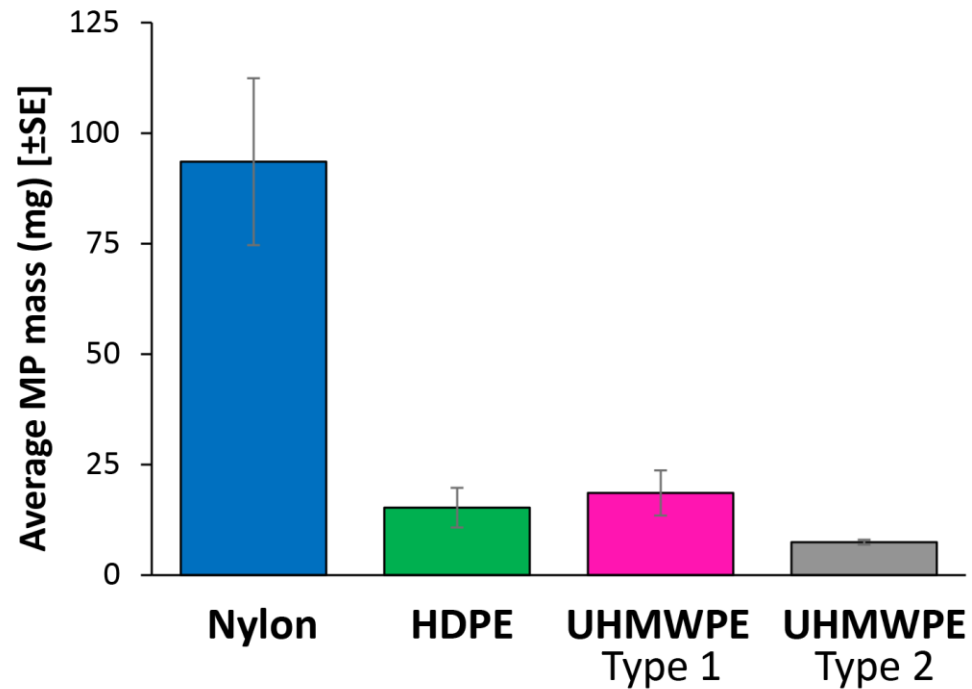
Effect of **MATERIAL**

Nylon nets release more MP than HDPE and UHMWPE

- Nylon nets may release significantly more MP than HDPE and UHMWPE under regular pressure cleaning .
- Coating performance differs strongly between net materials:

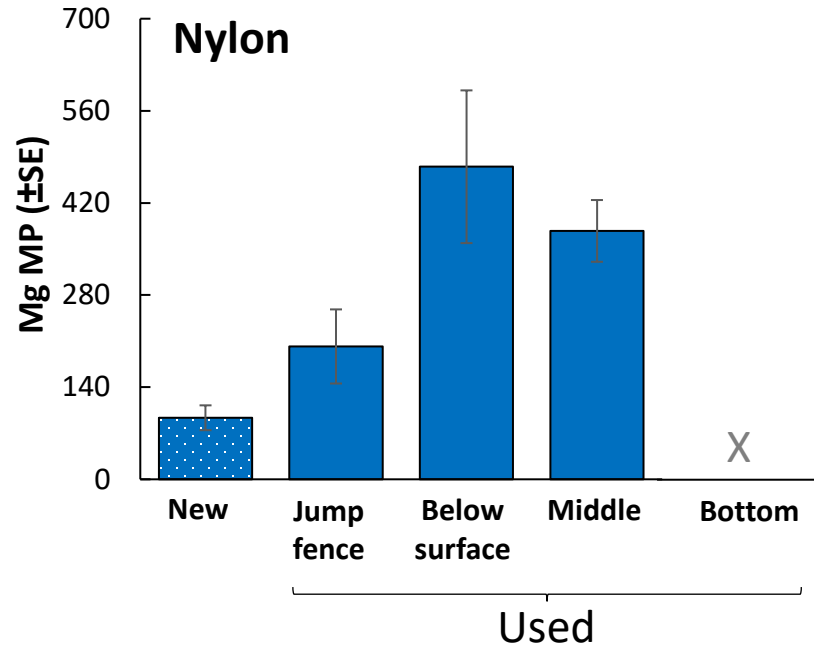
Age leads to increased MP release

- Actual MP particle counts were generally low and often indistinguishable from background MP levels.
- Used nets appeared to release more MP than new ones, especially in areas prone to abrasion. Residual coating may have influenced the amount of MP measured.

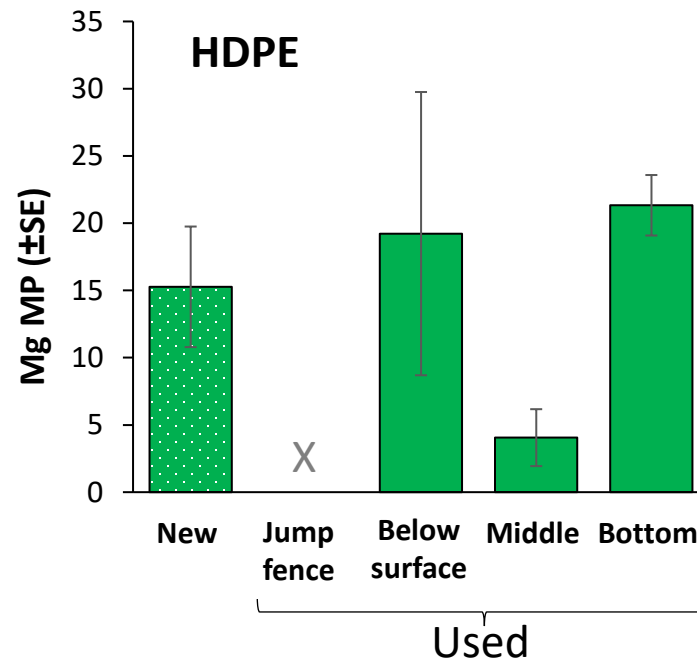
Little effect of age
(! Test net was not very old !)

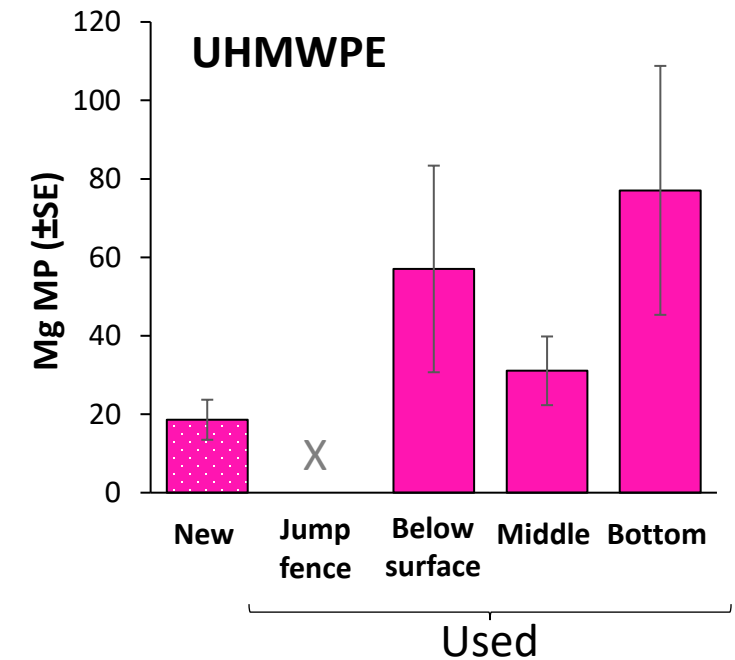
Age leads to increased MP release?
(! Copper coated net !)

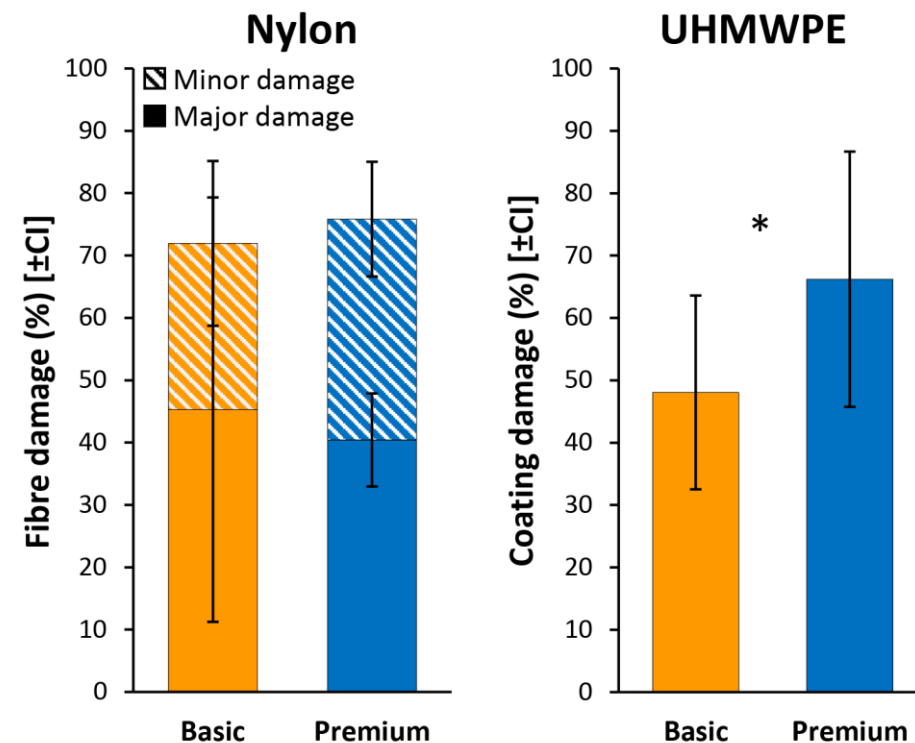
Microscopic assessment of the damage

Nylon

Damage to fibres, no difference between coatings

UHMWPE

Mostly coating damage, more visible for the premium coating

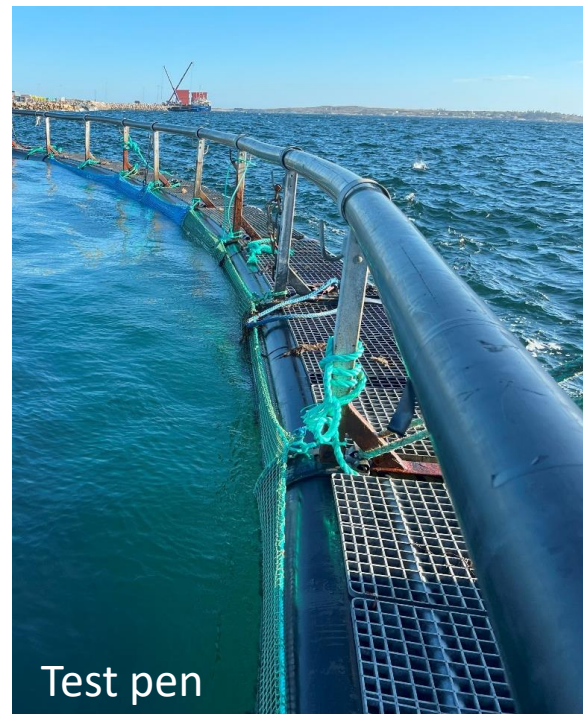
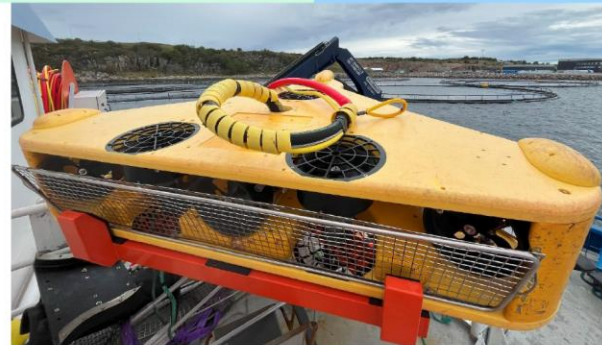
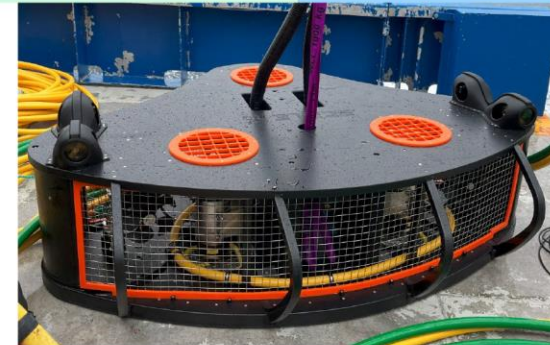
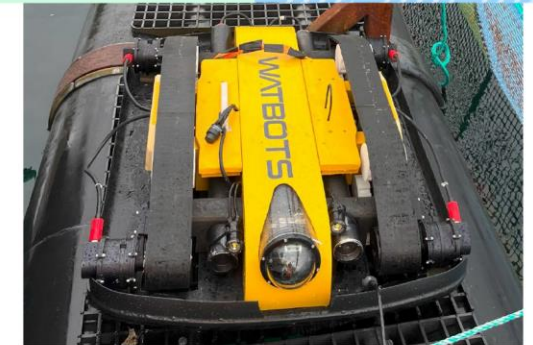
Pressure cleaning 70 passes 93 bar, 600 L/min		Cavitation cleaning 70 passes 148 bar, 200 L/min		AUV brushing 300 passes Horsehair brushes, both sides		
10m	10m	Used Nylon	New, coated Nylon		Repl. 1	Repl. 2
						Repl. 3

Schematised experimental set-up to simulate 10 months of net cleaning at sea testing three technologies on two net materials.

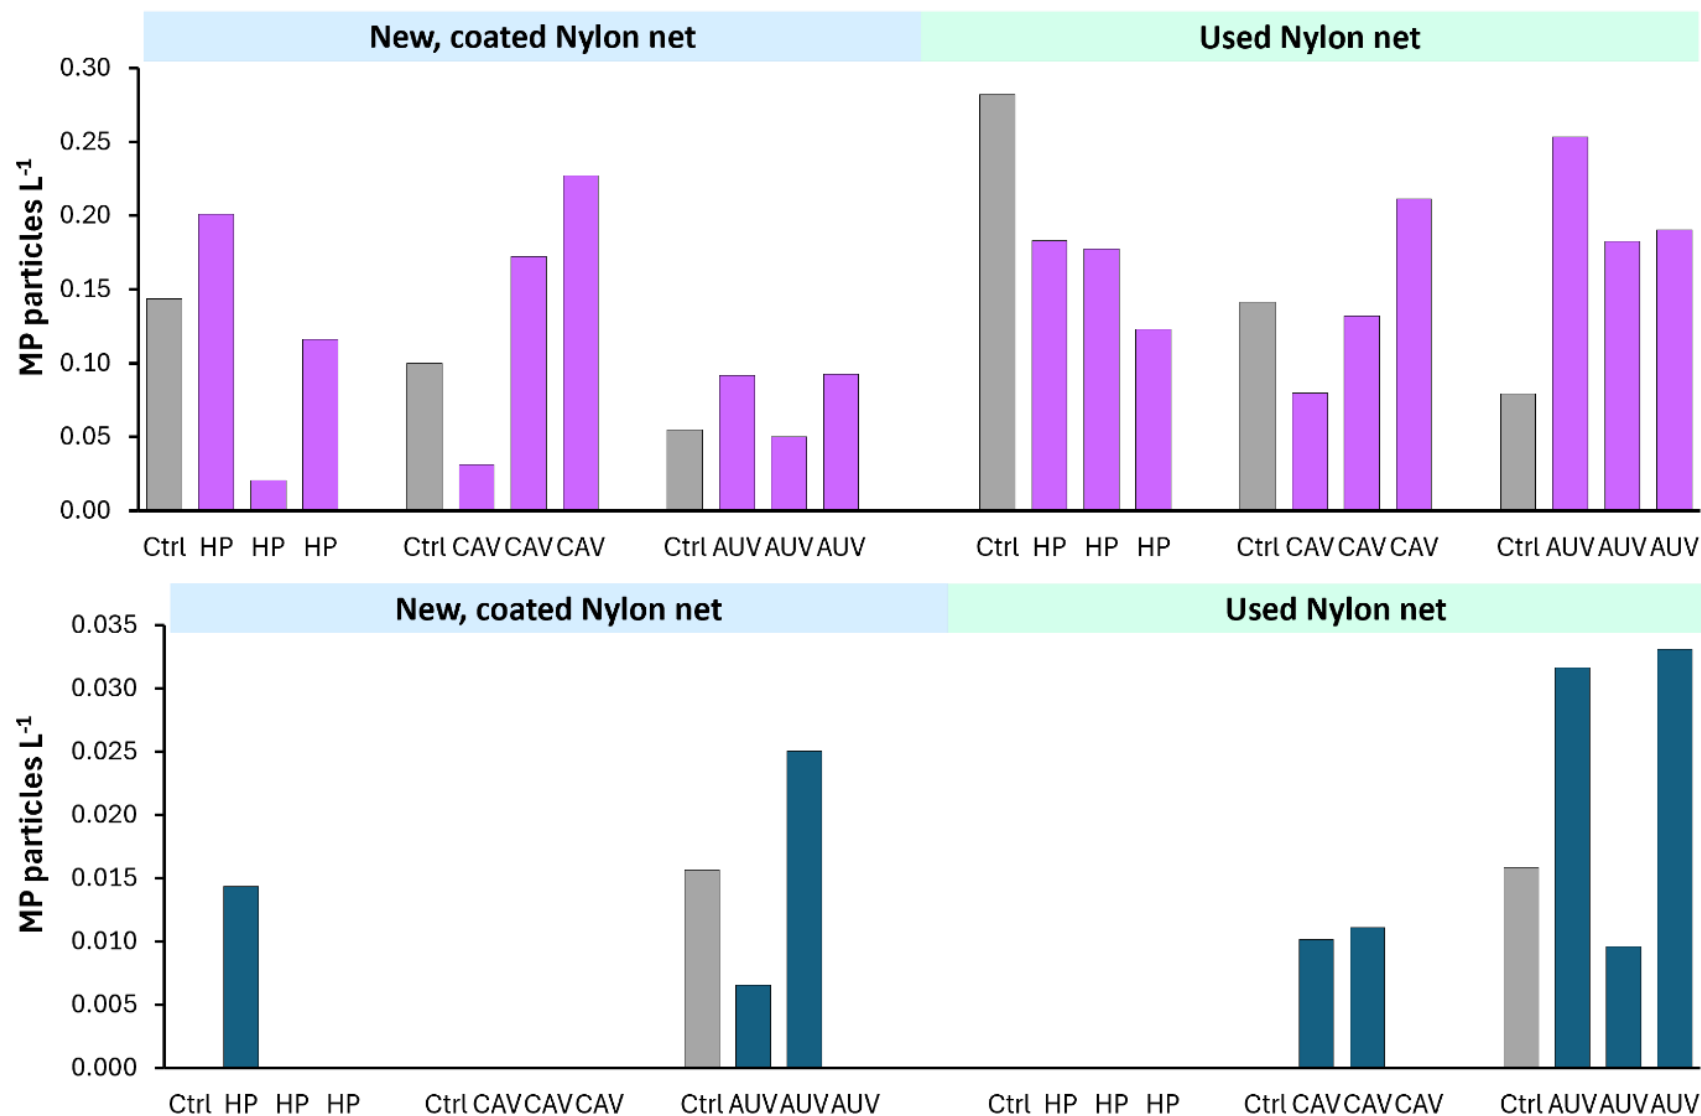
→ No difference between control and washing, or the technologies

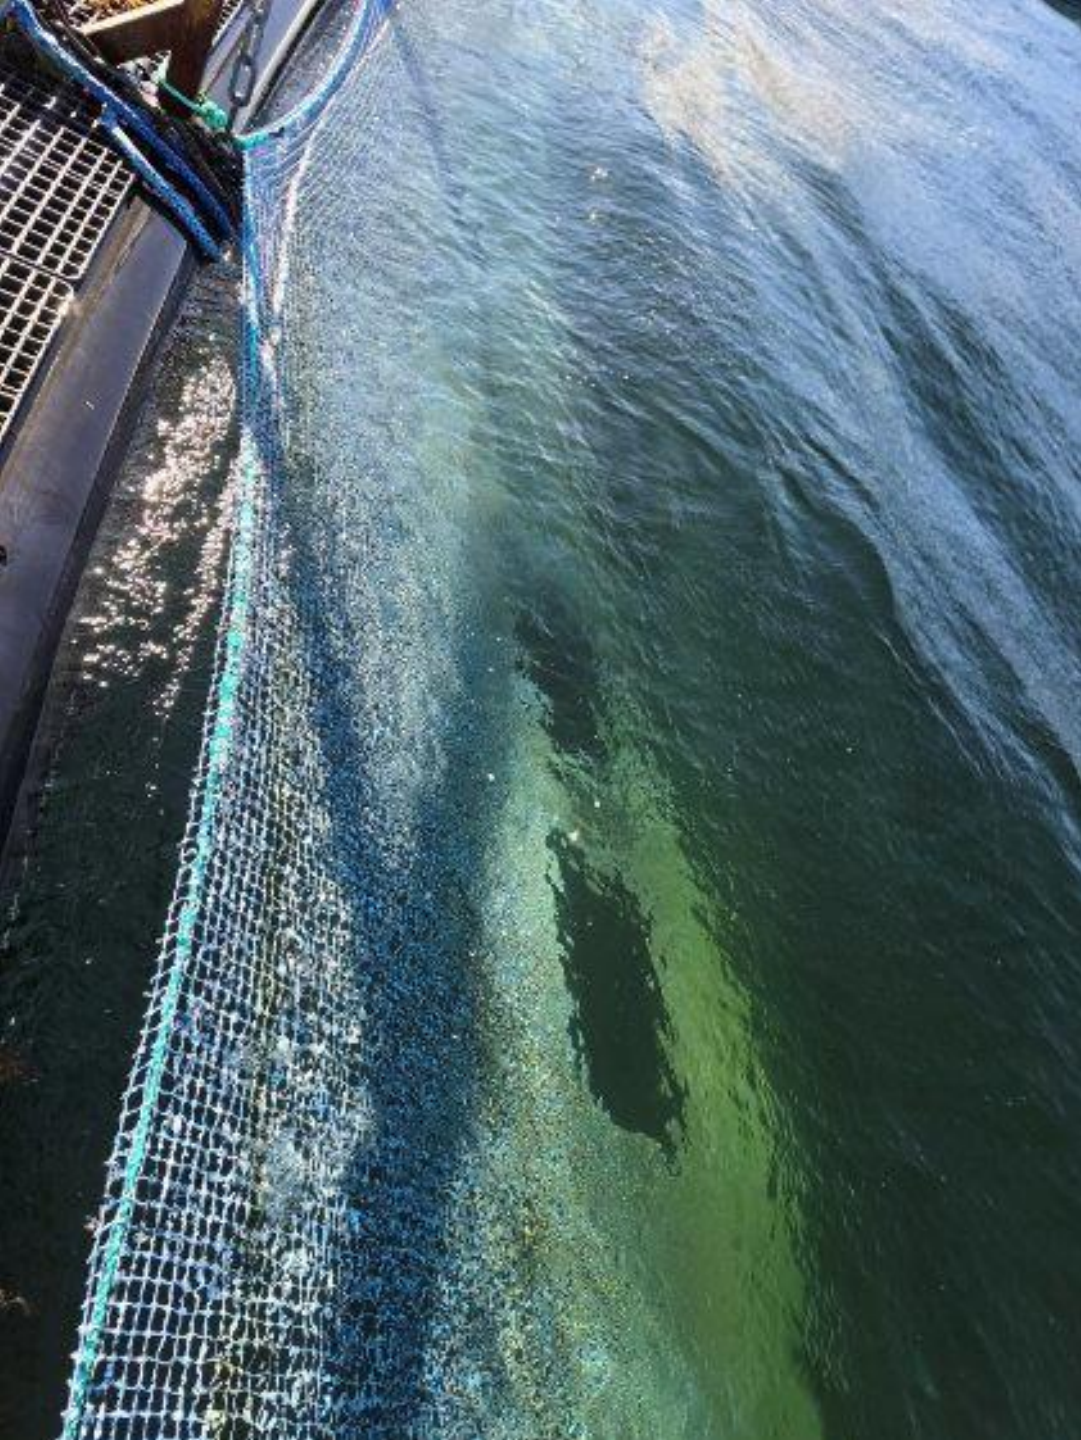
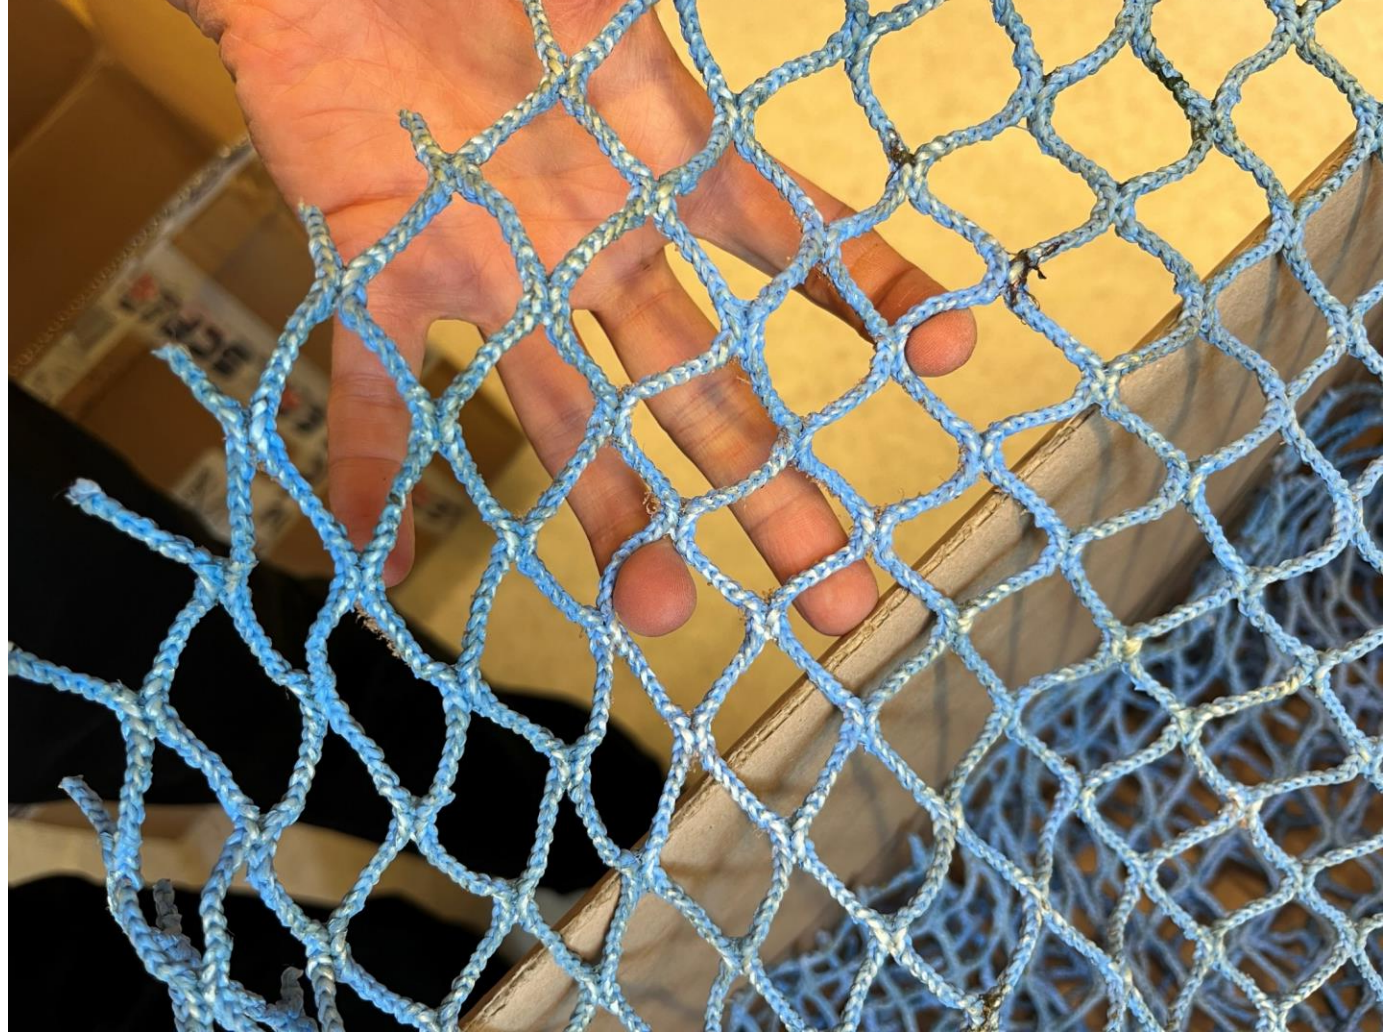
Net samples (50 x 50 cm) taken from
3 m depth after final cleaning

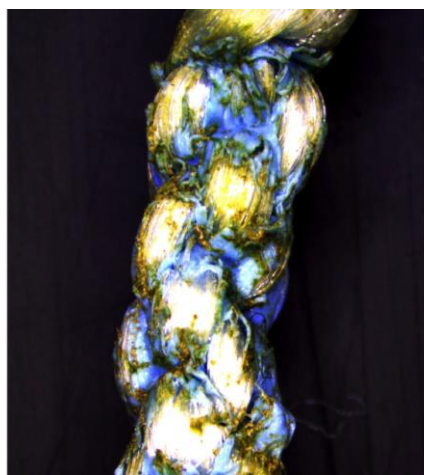
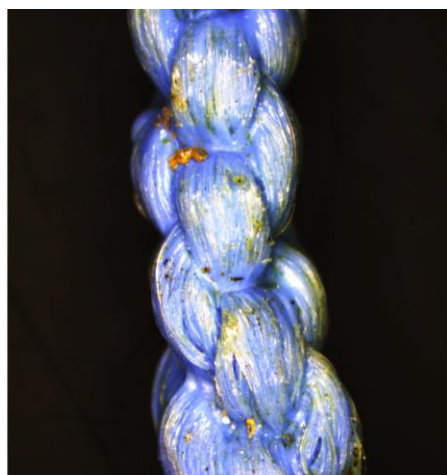
Pressure cleaning

Cavitation cleaning

AUV brushing

Thinned coating

Broken coating

- Pressure and cavitation cleaning caused more severe coating damage.
 - AUV brushing caused a more uniform thinning of the coating → Possible nanoplastic emissions.

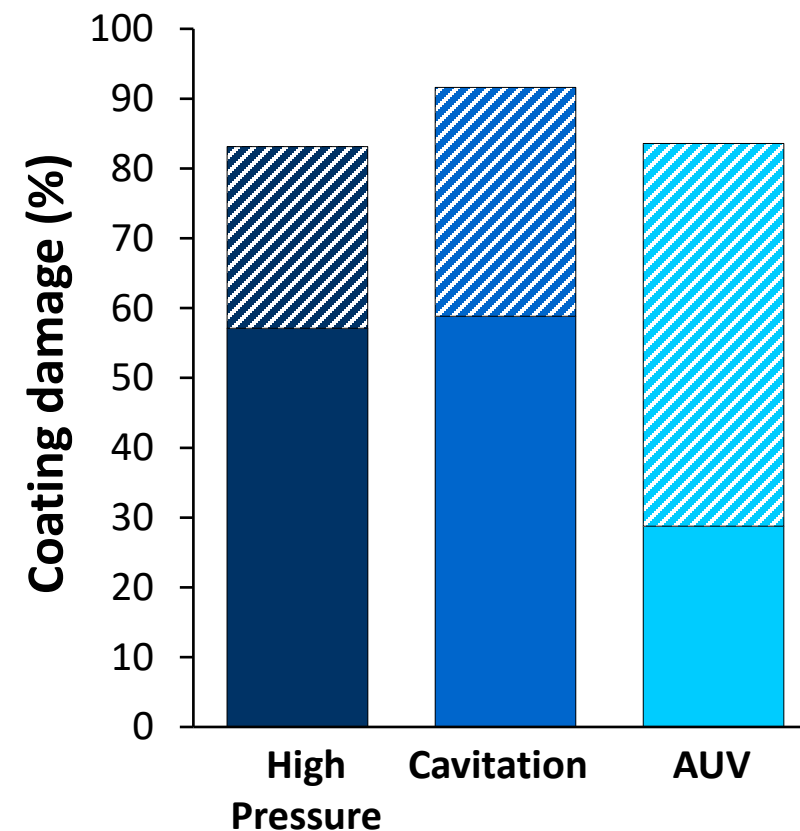
→ Total affected area is similar, but damage is less severe after AUV brushing (NP?)

→ No damage to the net fibres

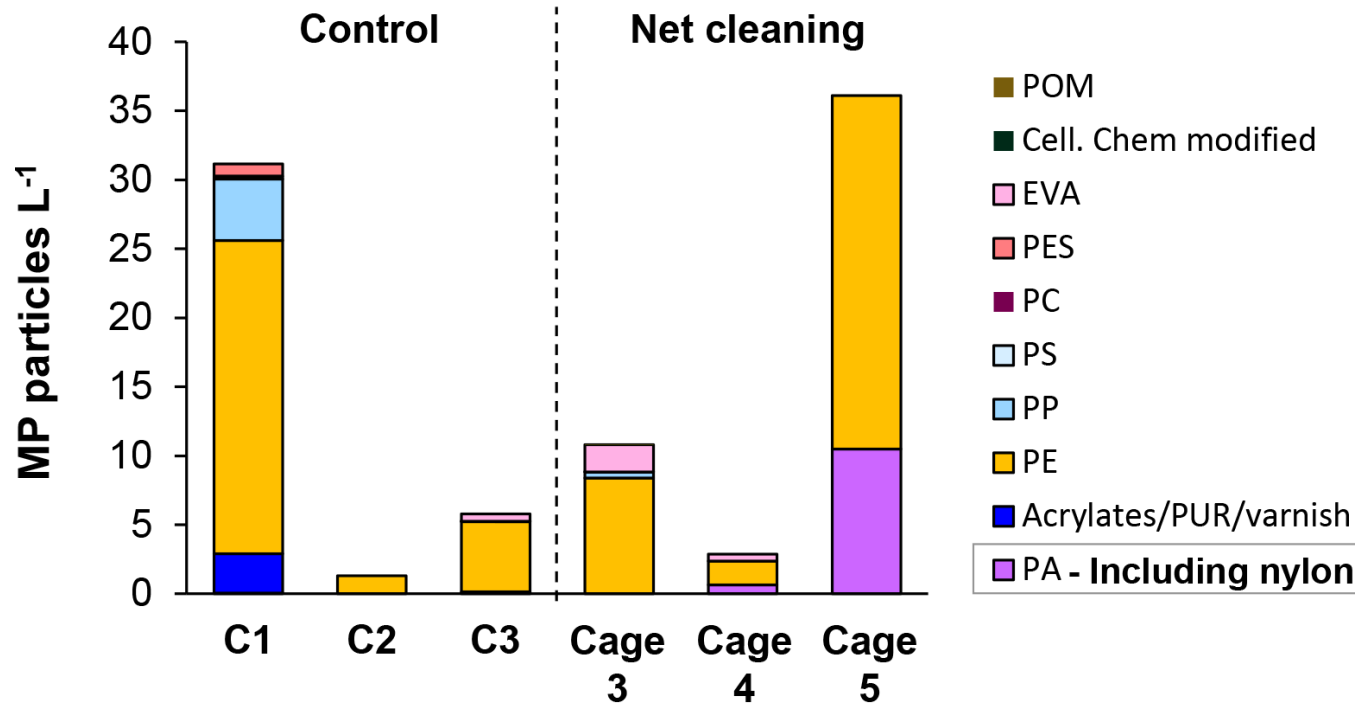
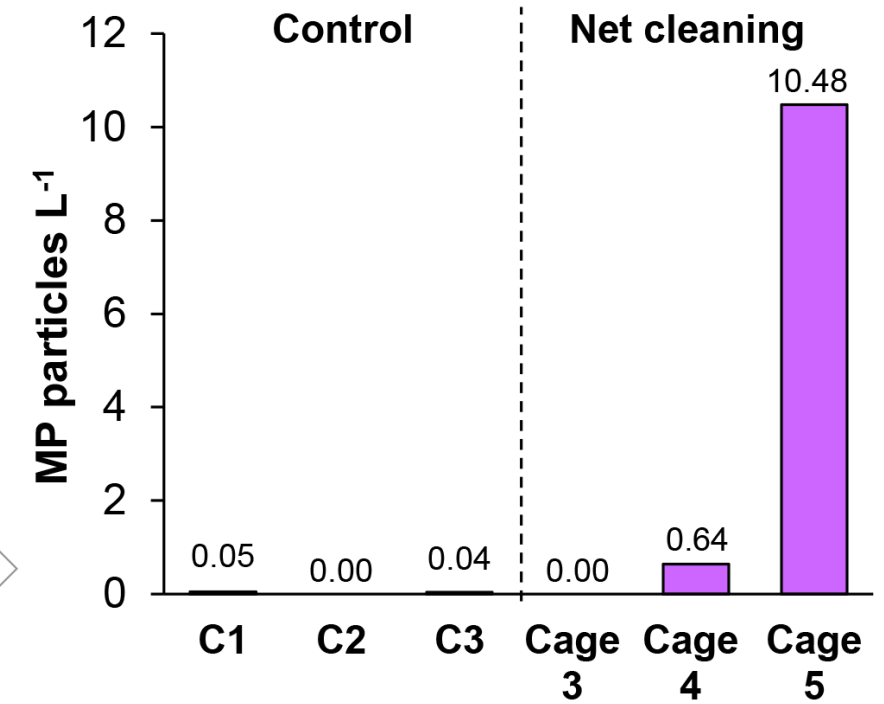
- Samples from an active net cleaning operation at a commercial salmon farm using two Manta units.
- Variability in MP concentrations and polymer compositions across the water samples collected during pressure washing of 3 aquaculture cages and 3 control samples collected at the same site.
- The presence of lice skirts on Cage 3 and Cage 4 may have impacted the amount of MP sampled.

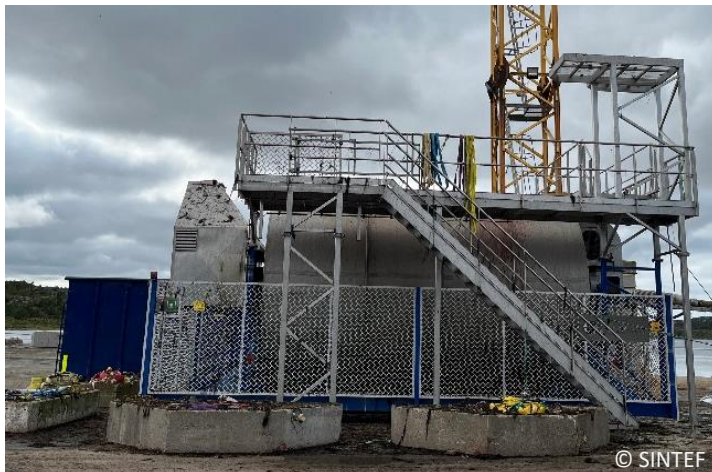
Sampling conducted at 4 time points and 3 locations:

- Initial reservoir sample
- Reservoir sample post-seawater addition
- Intermediate filter stage
- Post-filtration discharge tank

Filter → Seawater?

Drum washing does cause abrasion, but no release into the water if filtration applied

- Filtration systems at service sites are effective at retaining MP.
- MP were measured at an actual site, so there is release from aquaculture farms.
